**Subject:** MX South Canopy Electric - conduit gaps

## McKnight Crossings Church South Canopy Exterior Electric

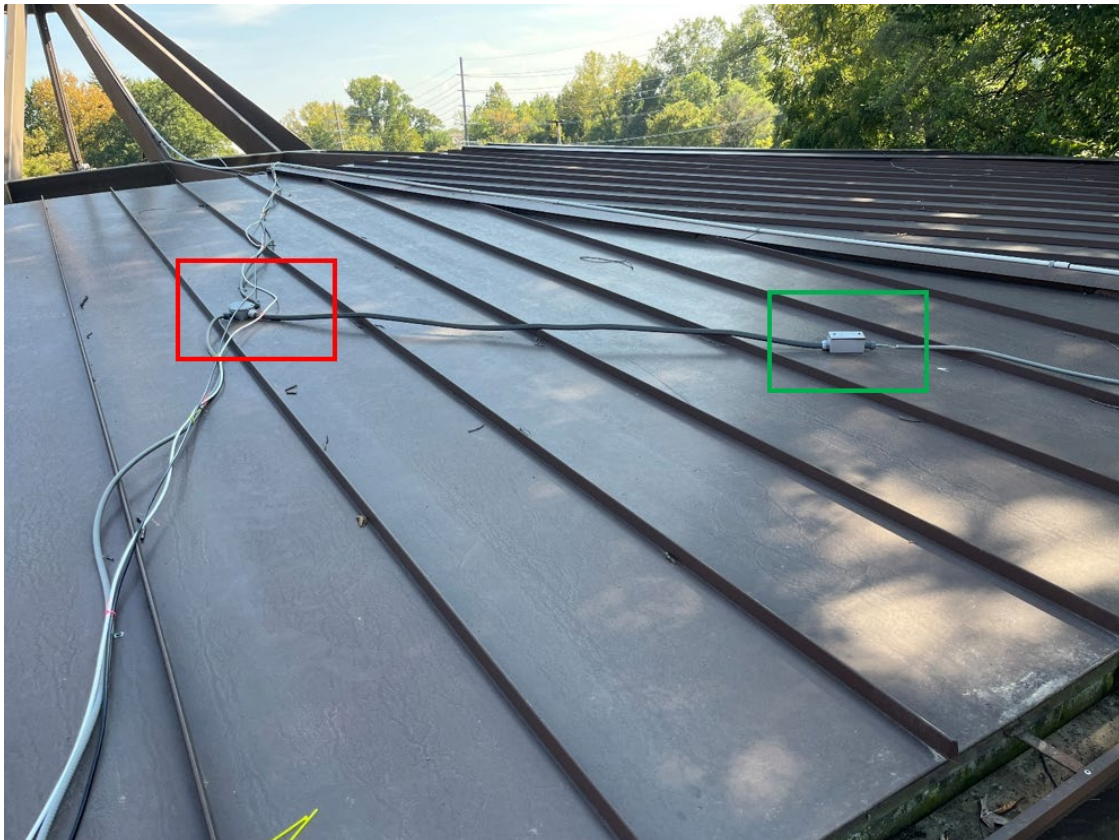
1. Conduit Separation: The conduit has pulled free from the junction box connectors, leaving gaps where it should be sealed.
2. Wire Exposure Risk: Only the outer sheathing of the three internal electrical wires is exposed, not the copper conductor. However, UV damage and weather could deteriorate this sheathing over time, exposing the copper to the elements.
3. Water Intrusion Risk: Gaps in the junction boxes could allow rain or snow to enter, potentially causing short circuits inside the boxes.

Below shows the two junction boxes that have the electrical conduit pulling free from the junction box connectors, exposing the 3 internal electric wires and opening the junction boxes to the elements – rain and snow – which could cause shorts in the boxes where the wires are joined. These exposed wires are noted in better detail in close-up photos later in this document.

The conduit should be terminated to the junction boxes with no visible wire showing and eliminating any possible water penetration into the junction boxes. There does not appear to be enough slack in the existing conduit to reach and reconnect fully to the junction boxes and it may be necessary to cut the conduit short, add another junction box to the existing conduit and add new conduit from the new junction box to the existing junction box.

Covering the exposed inner wire with electrical tape is discouraged.

This issue has probably been in existence for months if not years so no immediate rush to correct. However, this should be put on the [ToDo list](#) and prioritized.

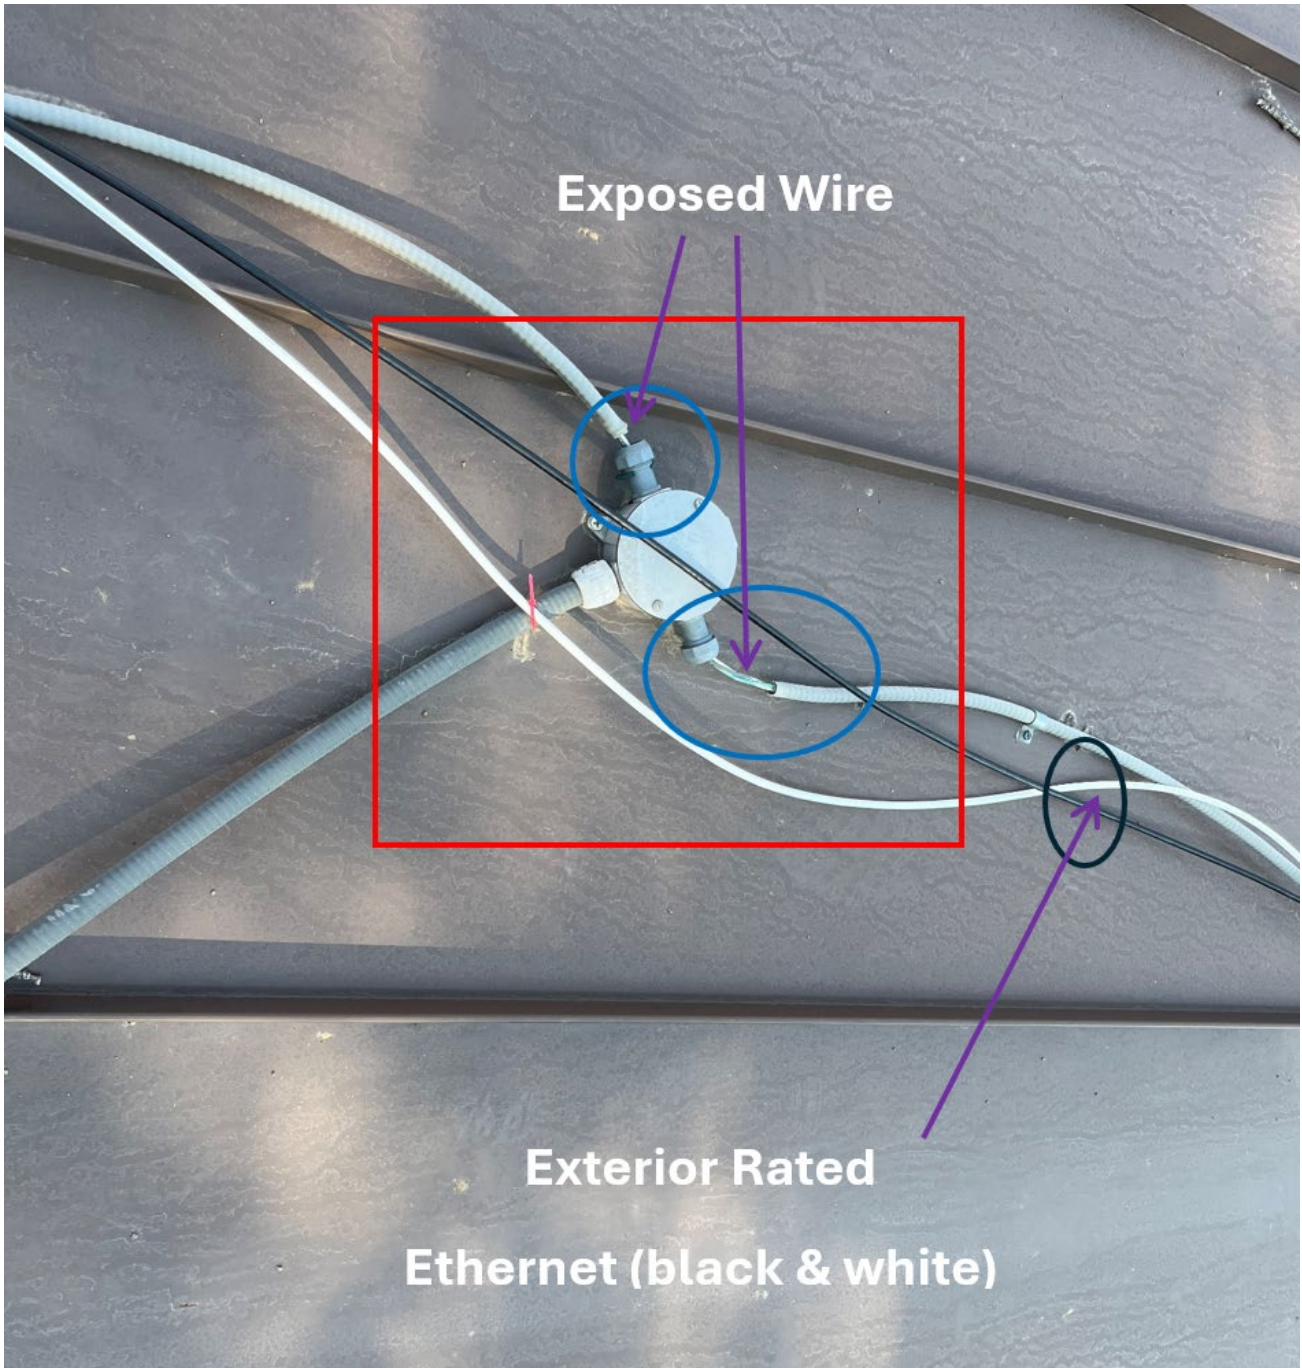
Below is a close up of the two electrical junction boxes noting how the conduit has pulled free from the box exposing the 3 internal wires (which are still individually sheathed).

The opening in the junction box can allow water from rain and snow to enter and possibly short on the internal wire connections.

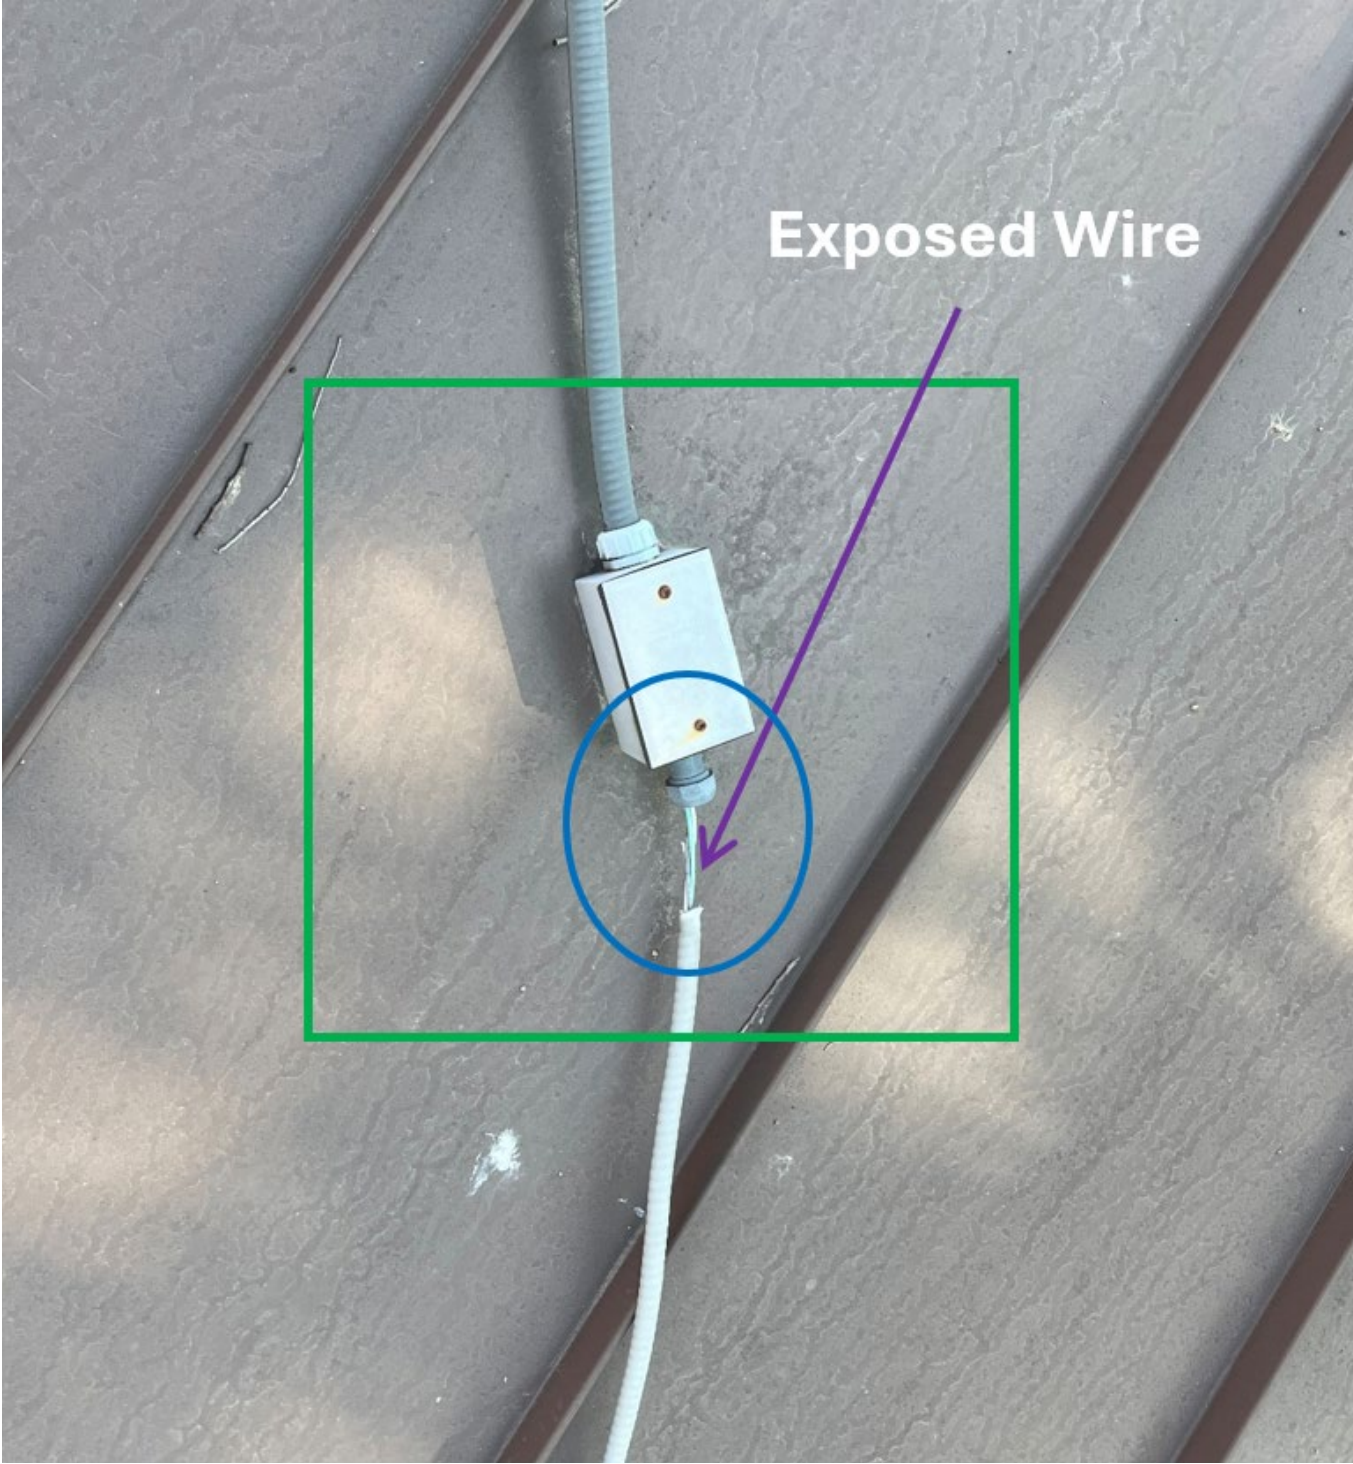
Close up of the other junction box where conduit is pulling away from the box.
